Lake Accotink Dredging

Alternatives Analysis

Alternatives Analysis Report

Project # SD-000041-001

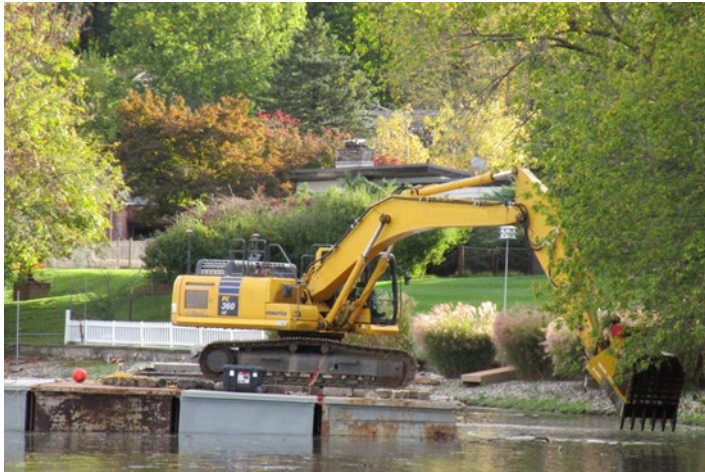
Mechanical

8 cubic yard bucket
16 cubic yard bucket

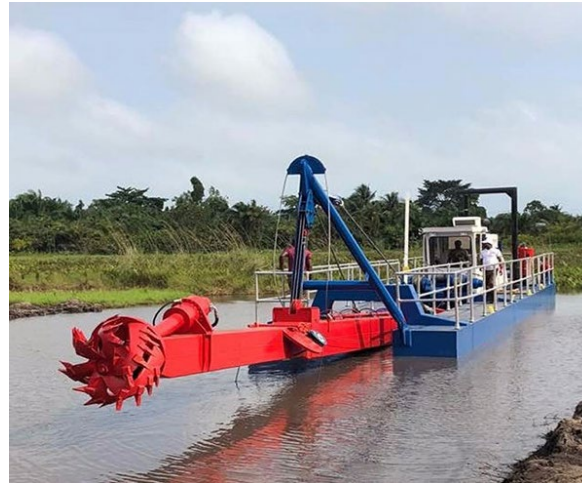
Hydraulic

8-inch dredge
14-inch dredge

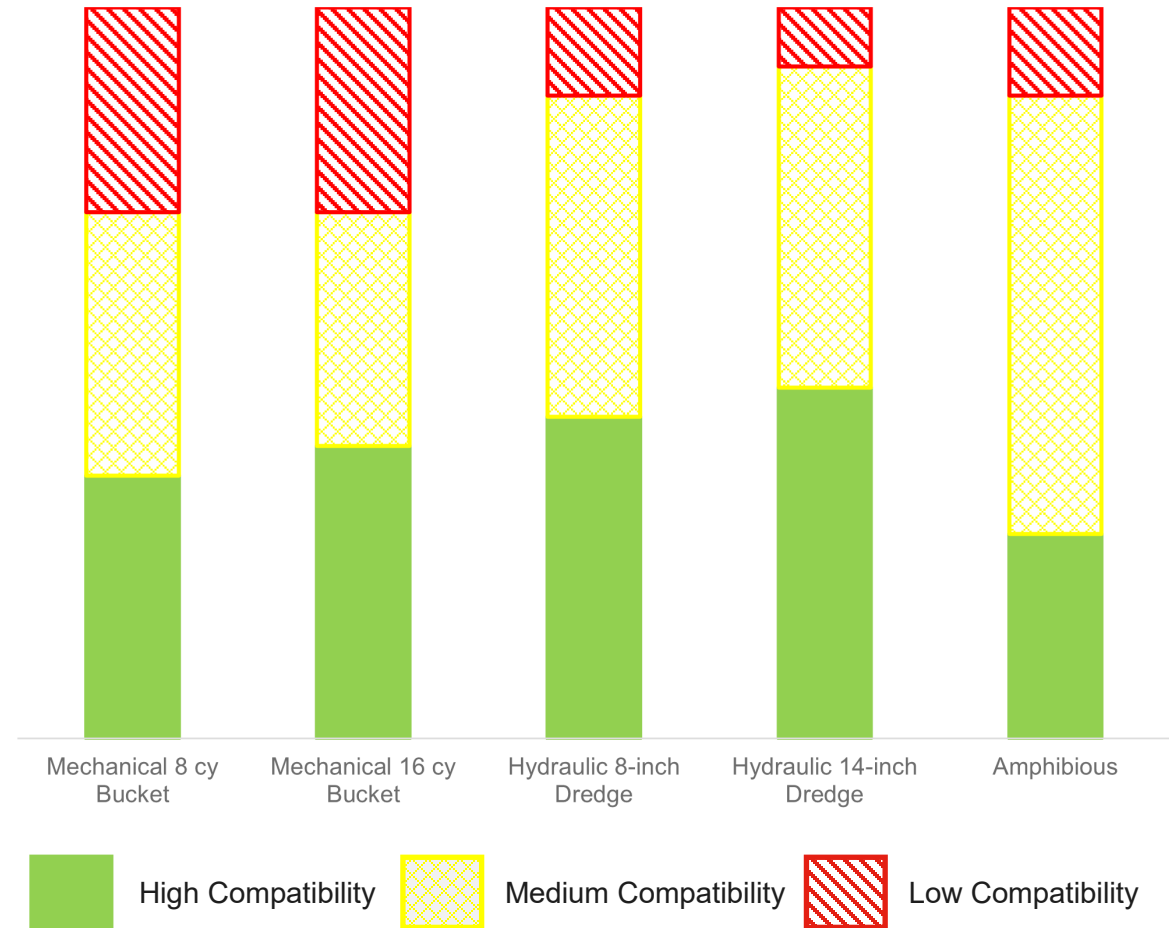
Dredging Method Evaluation

- All options are feasible
- Main challenges (red ratings)
 - Hydraulic – debris handling
 - Amphibious – production rate
 - Mechanical – community and floodplain impacts

Detailed Evaluation in Exhibit 1 of Alternatives Analysis Report

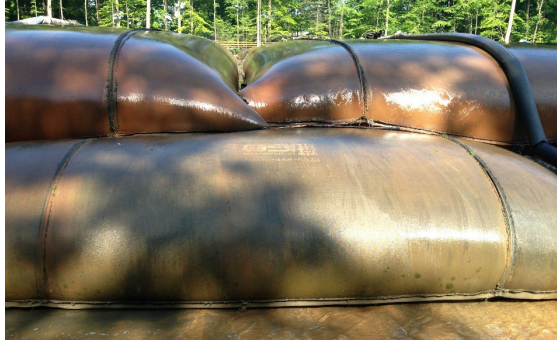
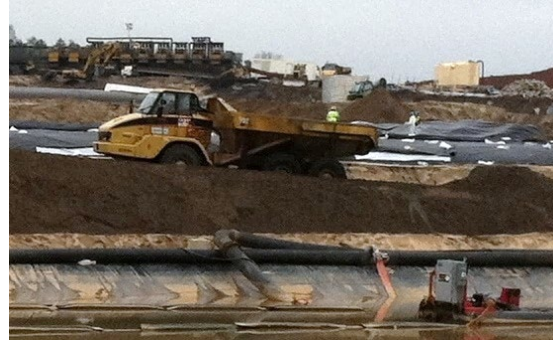
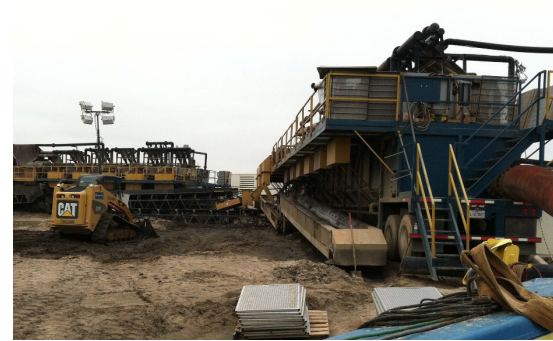
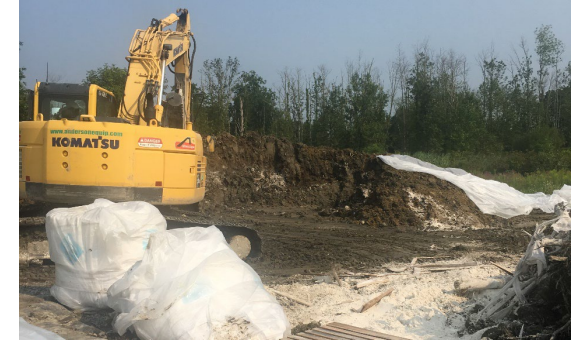
Dewatering Methods

PASSIVE (GEOTEXTILE TUBE)

3.5 – 4.9 acres

PASSIVE WITH DESANDING

5.2 – 7.4 acres

MECHANICAL

3.2 – 5.8 acres

DRYING AGENT

- Passive is simple and relatively low-cost but needs large, flat area
- Mechanical can accommodate higher throughput and creates drier material but is higher cost
- Identify location to provide most flexibility for contractor's approach

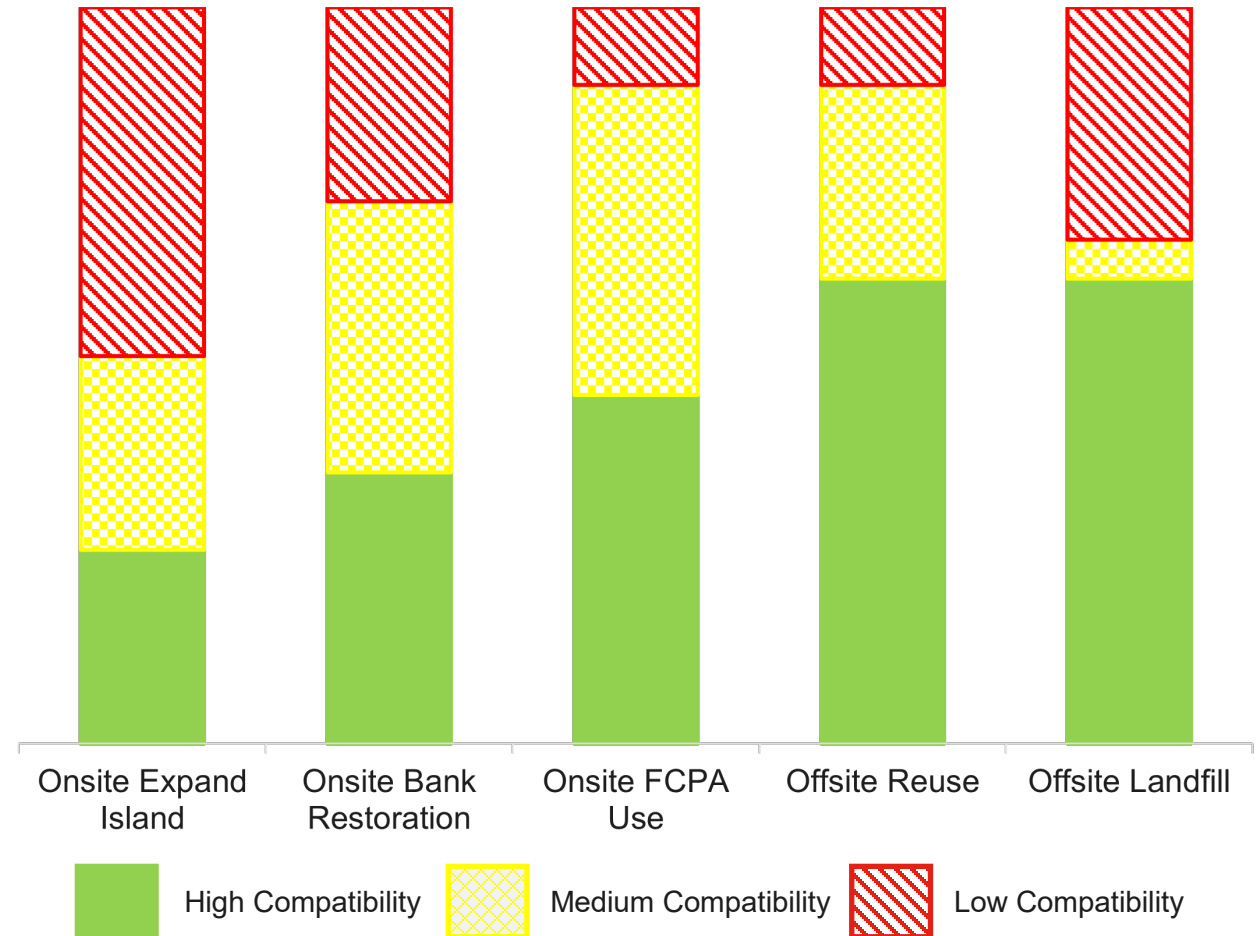
Disposal Location Evaluation

- All disposal locations can be paired with any of the dredging and dewatering options
- Offsite landfill and offsite reuse have no public impacts but have higher costs
- Onsite reuse has lower costs but has public impacts

Detailed Evaluation in Exhibit 3 of Alternatives Analysis Report

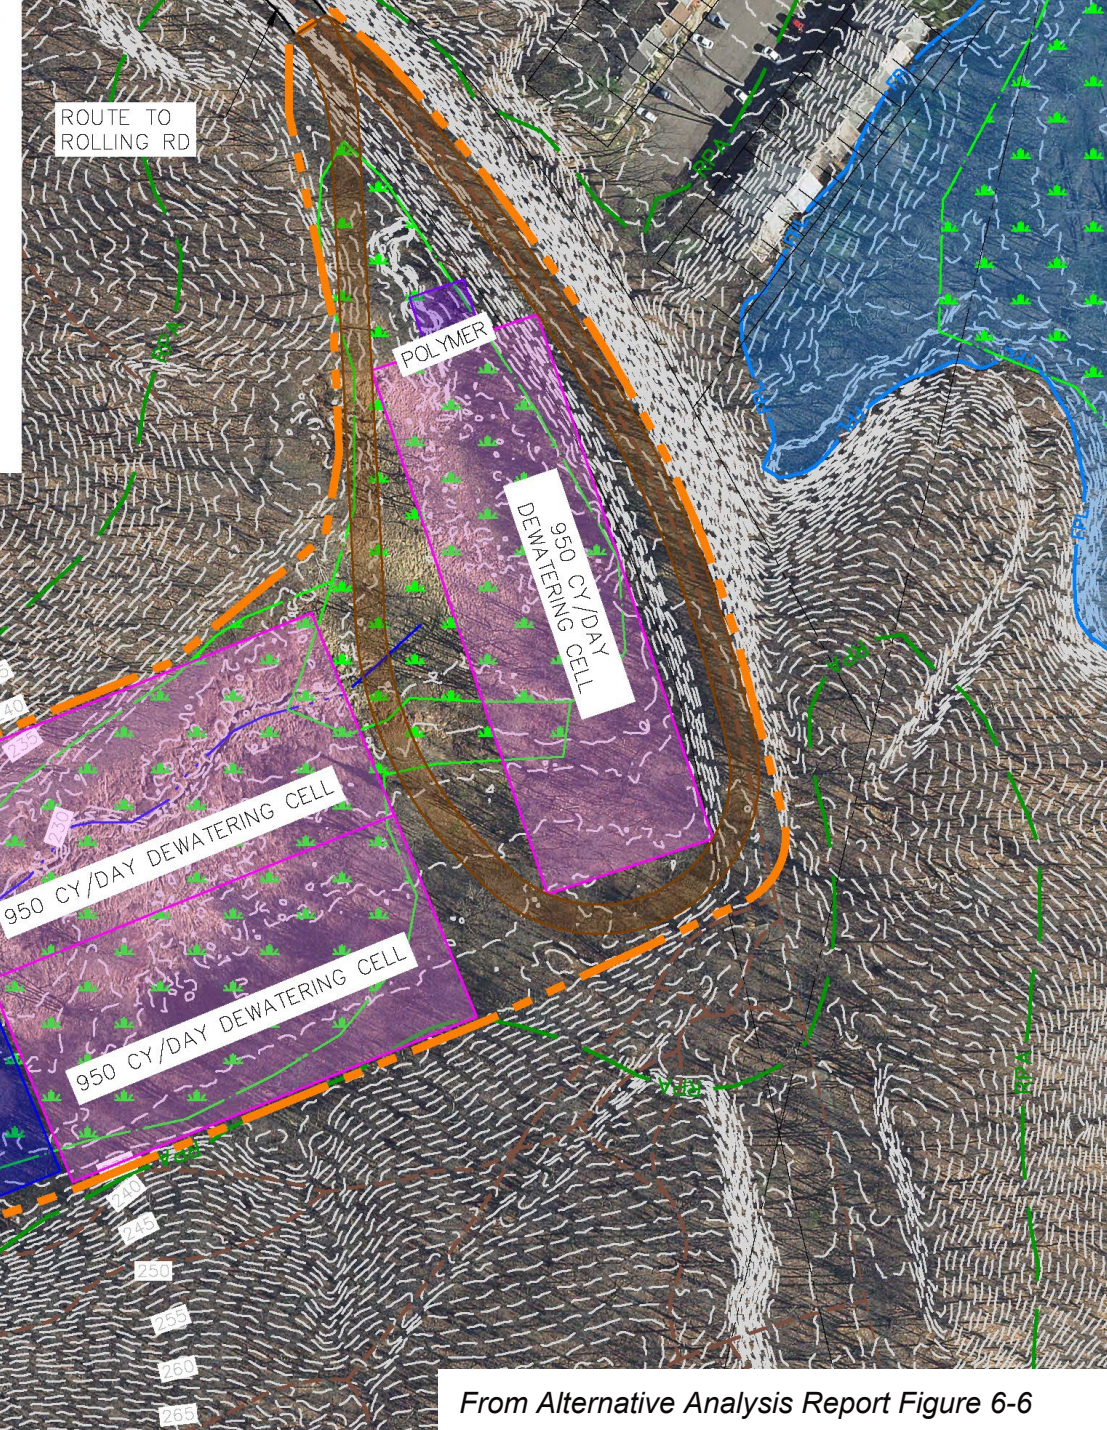
From Alternative Analysis Report Figure 6-6

Upper Settling Basin Slurry Transport Alignment

Upper Settling Basin – Trail Alignment	
Alignment	
Length, mi.	0.7
Pipe Diameter, inches	14 to 16
Difference in Elevation ¹ , ft.	70
No. of Utility Crossings ² , ea.	9
No. of Water Feature/Trail Crossings	15

1. Difference in elevation between highest and lowest point along the alignment.
2. Sewer, Stormwater, Electrical & Water.

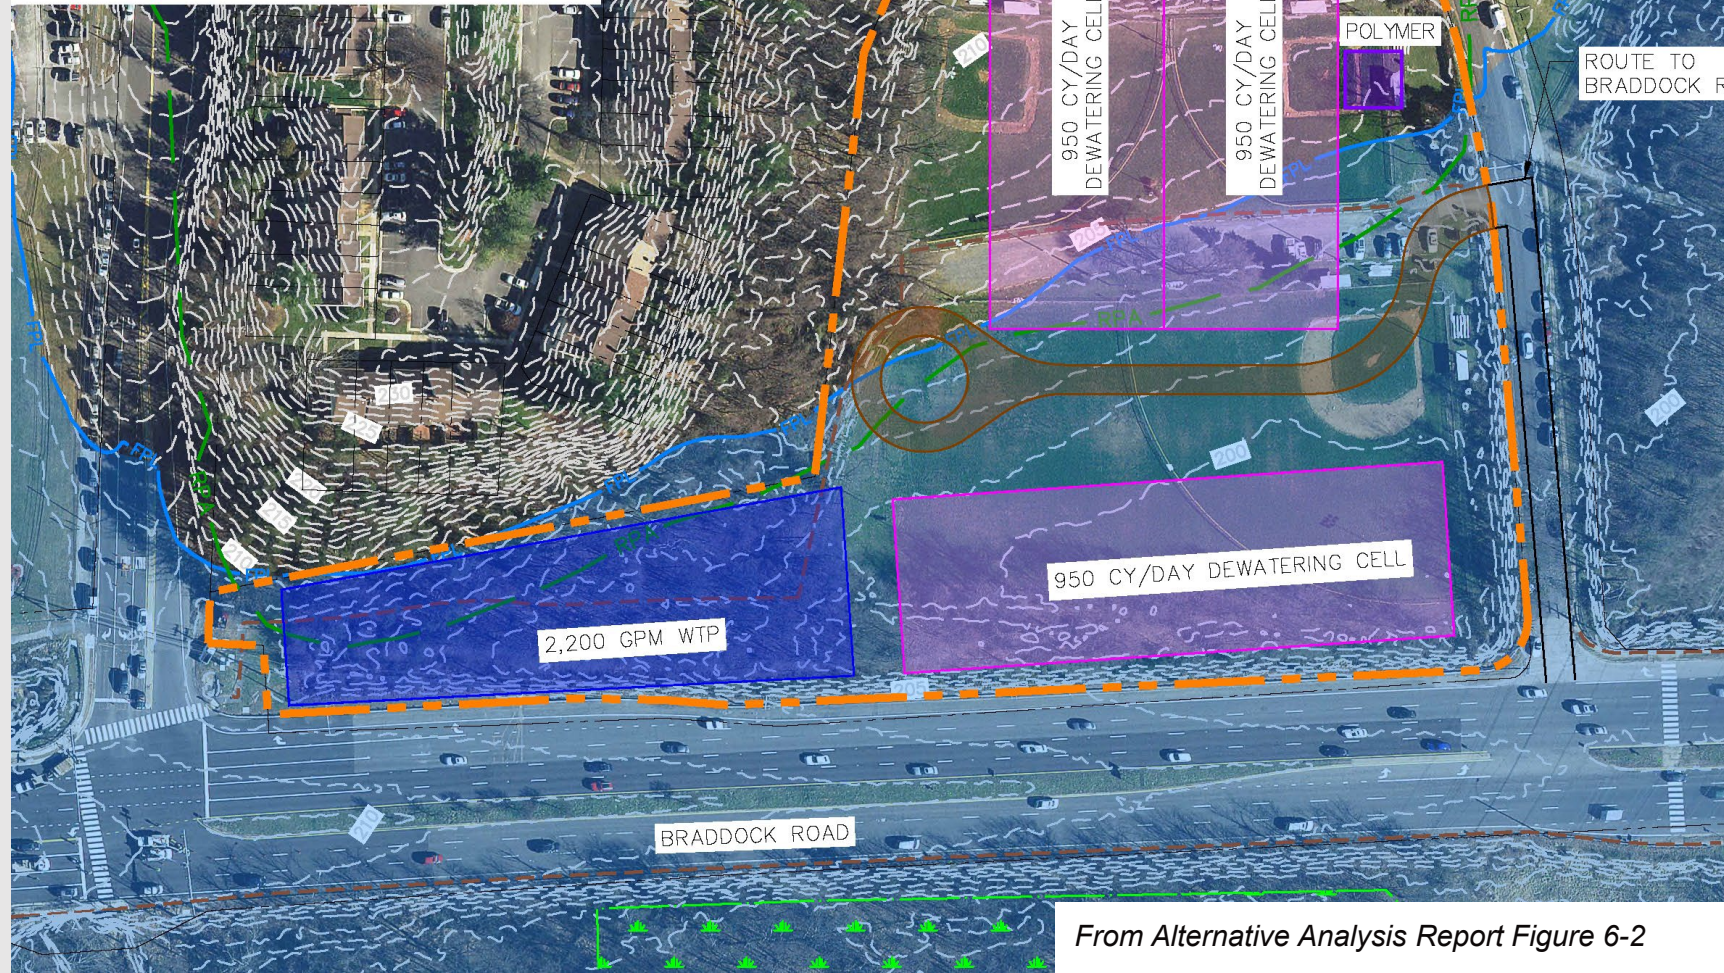
From Alternative Analysis Report Figure 6-2

Howrey Field Slurry Transport Alignments - County Staff Recommend Removal from Consideration

Type	HF1 - Cross-County Trail	HF3 - Flag Run/Port Royal Road	HF4 - Flag Run/I-495
Alignment

Length, mi.	1.3	2.2	2.2
Pipe Diameter, inches	12 to 14	16 to 18	16 to 18
Difference in Elevation ¹ , ft.	15	105	110
No. of Utility Crossings ² , ea.	27	59	37
No. of Water Feature/Trail Crossings	8	32	29

1. Difference in elevation between highest and lowest point along the alignment.
2. Sewer, Stormwater, Electrical & Water.

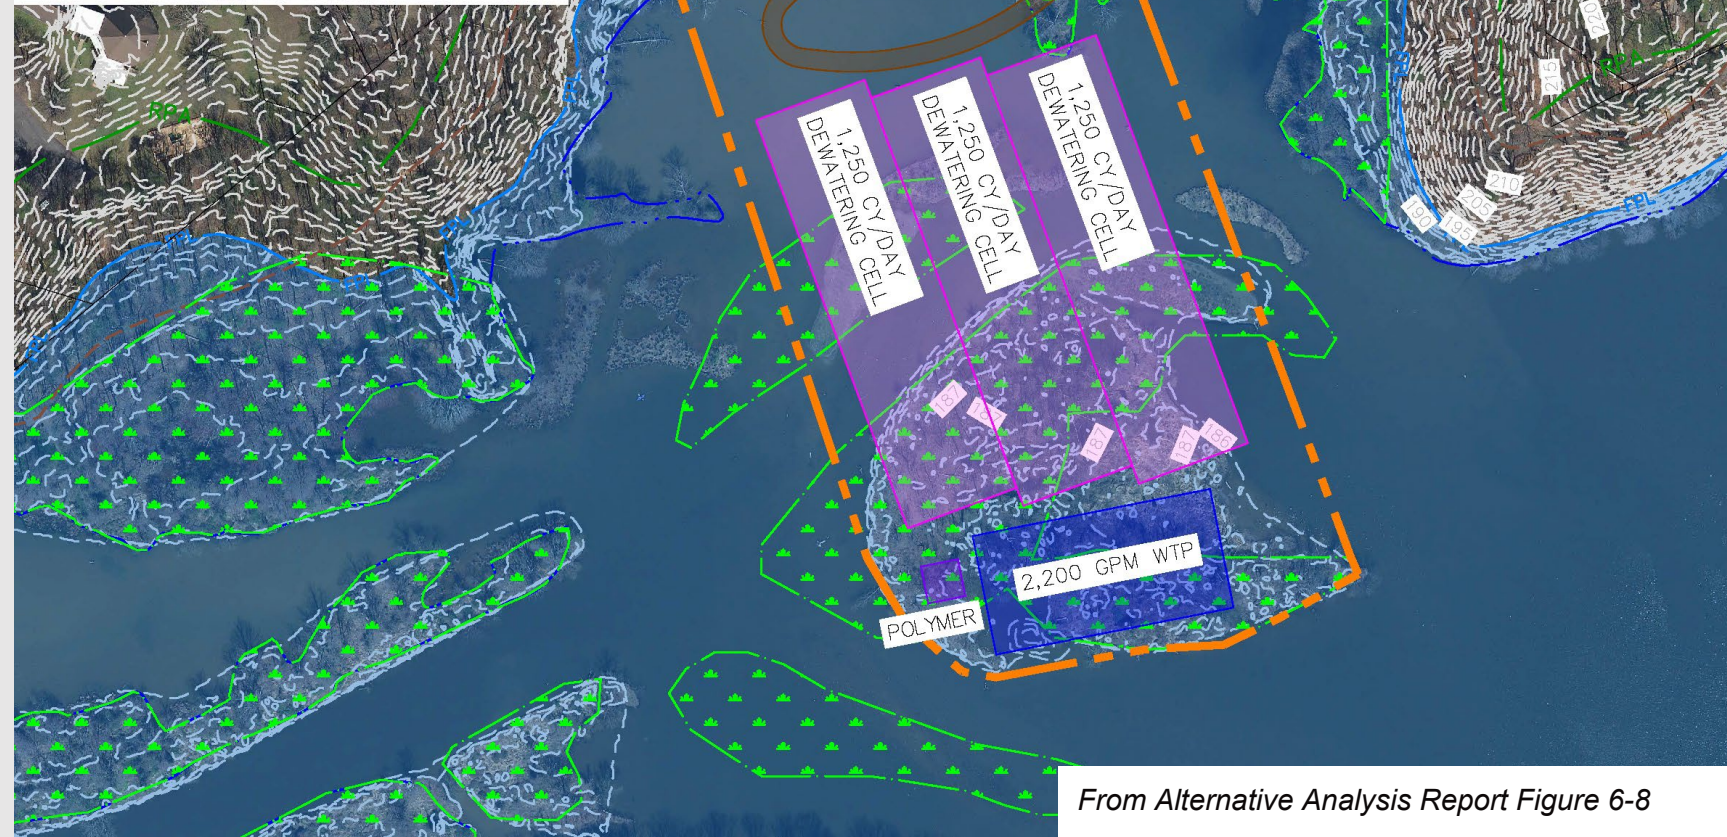
From Alternative Analysis Report Figure 6-8

LOW = Park and Environmental Impacts, Site Preparation, Accessibility, Truck Traffic, Floodplain, Cost
HIGH = No Pipeline, Water Return, Method Compatibility

- Surface/subsurface condition of island and land bridge area
