The *Middle Potomac Watersheds Management Plan* presents a strategy for mitigating the impacts of development and improving or preserving the water resources and natural habitat in the Bull Neck Run, Scotts Run, Dead Run, Turkey Run, and Pimmit Run watersheds, collectively known as the Middle Potomac Watersheds. The plan has three goals: human protection, habitat protection, and stewardship. It outlines recommended structural and nonstructural actions in each of the five watersheds which will help achieve the plan goals.

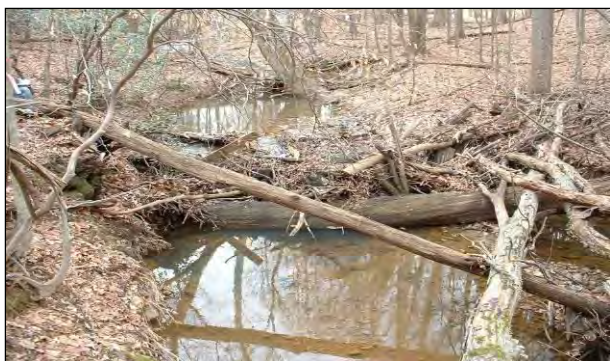
Fallen trees and debris are causing a severe impact to Bull Neck Run just north of Georgetown Pike

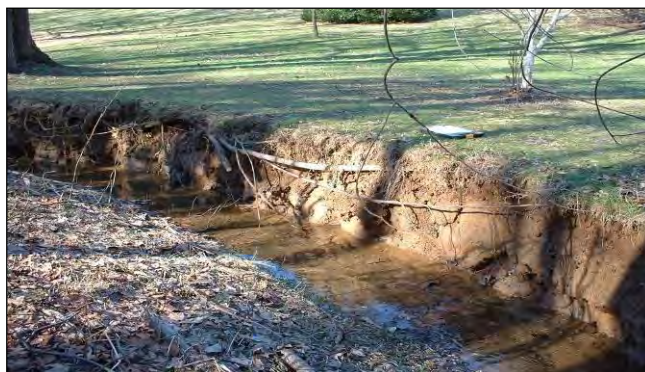
Severe erosion downstream of the Alvord Street crossing

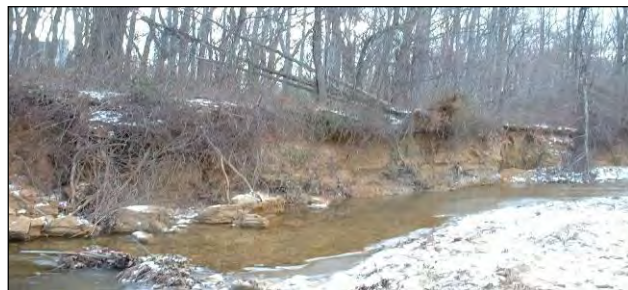
Severe erosion was observed at Scotts Run north of Old Dominion Drive

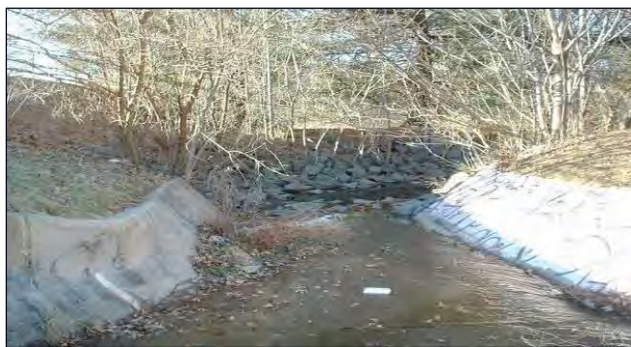
Concrete lined portion of Dead Run

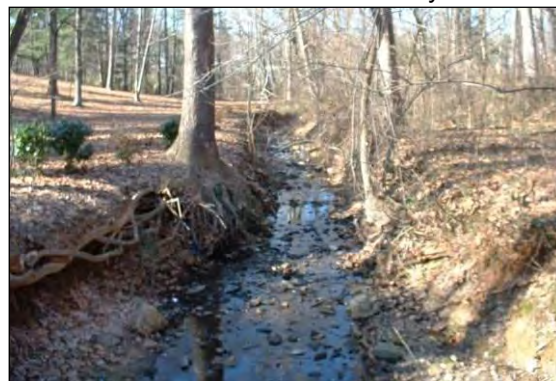
Eroded stream banks at a tributary to Dead Run near Churchill Road

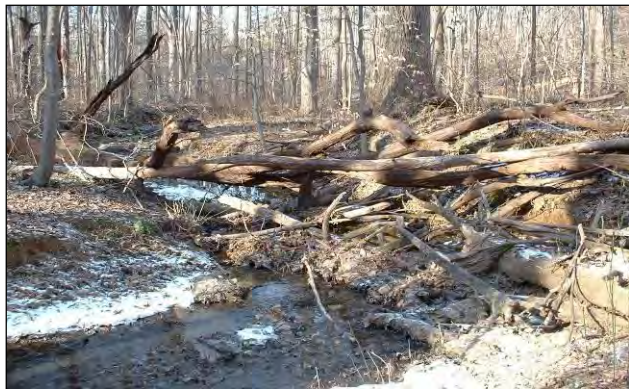
Fallen trees and debris are causing a severe impact to the stream east of Turkey Run Road

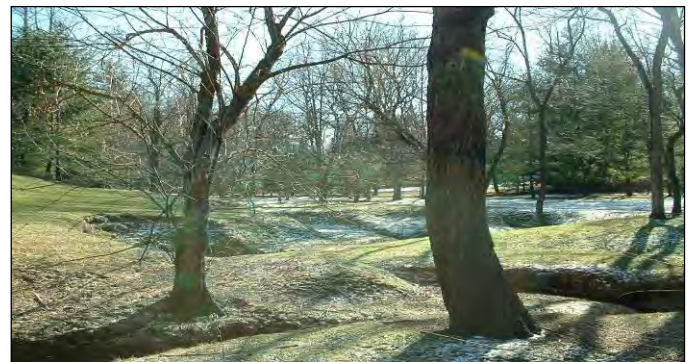
Poor buffer area southwest of Kedleston Court

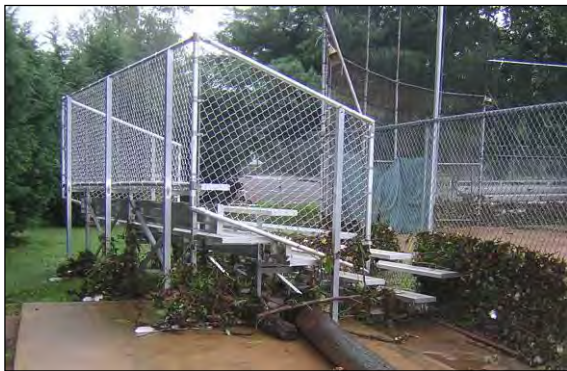
The McLean Little League ball fields after flooding

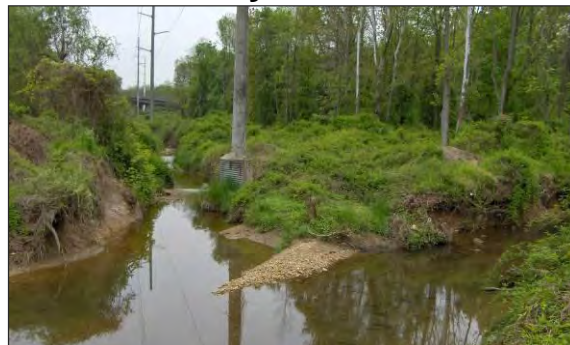
View of utility poles located in Pimmit Run

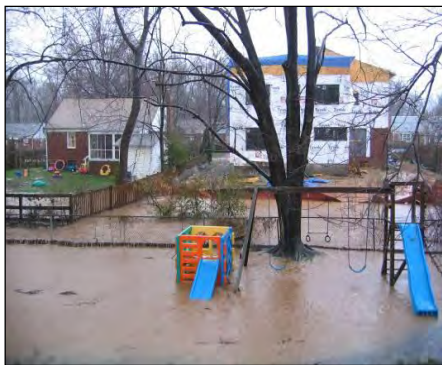
Backyard flooding near Chesterfield Avenue caused by increased runoff from impervious areas
