4.1 Horsepen Creek Watershed

Figure 4.1
Horsepen Creek
Watershed Management Area
Map

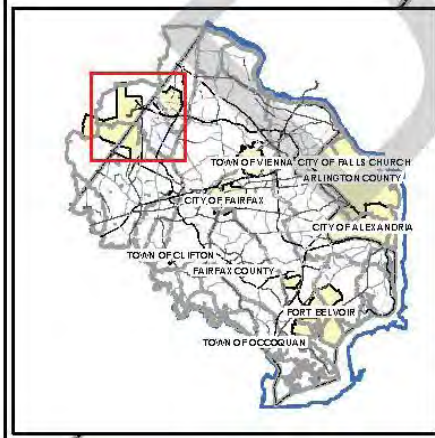
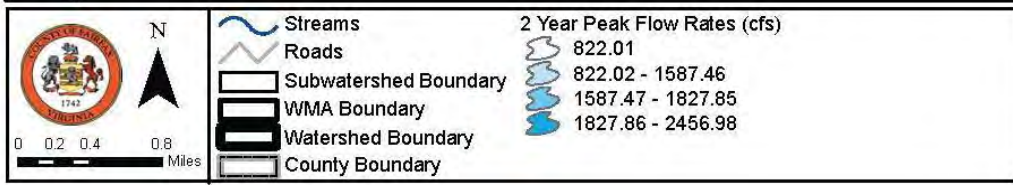
Figure 4.14
SWMM Peak Flow Map for
Horsepen Creek Watershed

The Stormwater Management Model (SWMM) was used to determine the peak rate (maximum volume of water per second) of stormwater flows in stream channels during a storm. The 2-year and 10-year storm flows were modeled; these are the storm flows that, on average, occur once every 2 or 10 years. Figure 4.14 shows peak rates of flow for the 2-year storm across the watershed. As shown in Figure 4.14, within each WMA, peak flows tend to increase downstream as more drainage area contributes more stormwater runoff to the stream channel. In a similar manner, an upstream, contributing WMA augments the flow in a downstream, receiving WMA. Because stormwater runoff flow carries pollutants, pollutant loadings also increase downstream within a WMA and from one WMA to the next.
