Accotink Creek Watershed Management Plan DRAFT

Watershed Workbook
October 2008

*Fairfax County Department of
Public Works and
Environmental Services*

October 2008

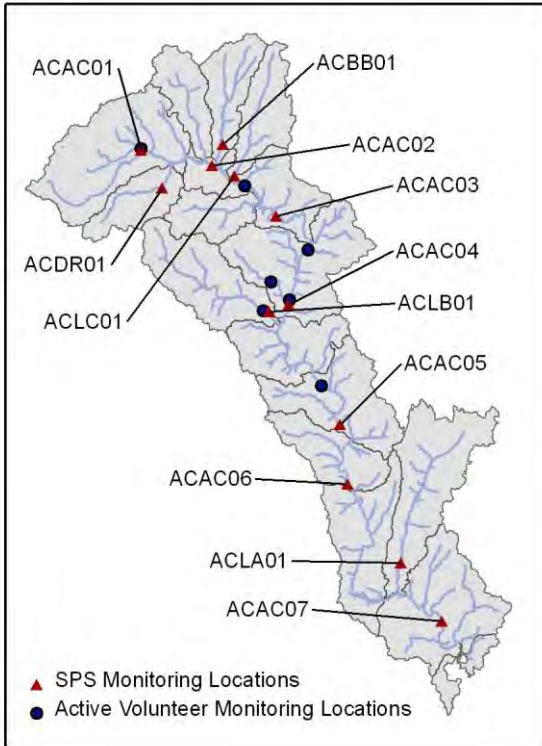
Figure 1 - SPS and Volunteer Monitoring Locations in Accotink Creek Watershed

The results of the data collected from the 12 sampling sites within the Accotink Creek watershed for the SPS Baseline Study are shown in Table 1-7 (listed generally upstream to downstream). Locations are shown on Figure 1, on the following page, with SPS monitoring locations labeled. The streams in the watershed are substantially degraded and most of the tributary streams exhibit poor habitat, poor biological conditions and a lack of fish diversity. Benthic macroinvertebrate community health was also poor throughout the watershed and nearly all of the insects collected were those tolerant of degraded conditions.

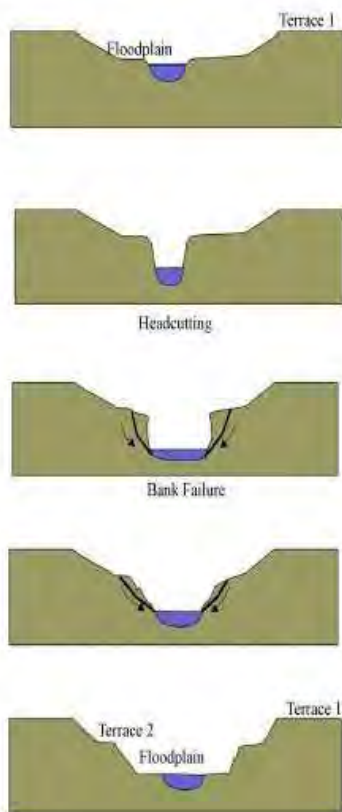
Figure 2 - CEM Categories

gives insight into how stream channels change after a disturbance such as a change in watershed land use. The CEM classifies streams into the five categories shown below in Figure 2, and can be useful for predicting future conditions:

Type I – This represents pre-disturbance condition, with well-vegetated streambanks.

Type II – This is the first stage after disturbances to the watershed. The dominant physical process in this stage is bed degradation, with the beginning stages of stream incision (downcutting).

Type III – At this stage bed degradation has led to overly steep banks, and bank failure is common. This stage is the most unstable of all CEM stages. Channel widening is the dominant physical process in a Type III channel.

The geomorphologic assessment of the stream channels in the Accotink Creek watershed is based on the Channel Evolution Model (CEM) (Schumm et al. 1984), which

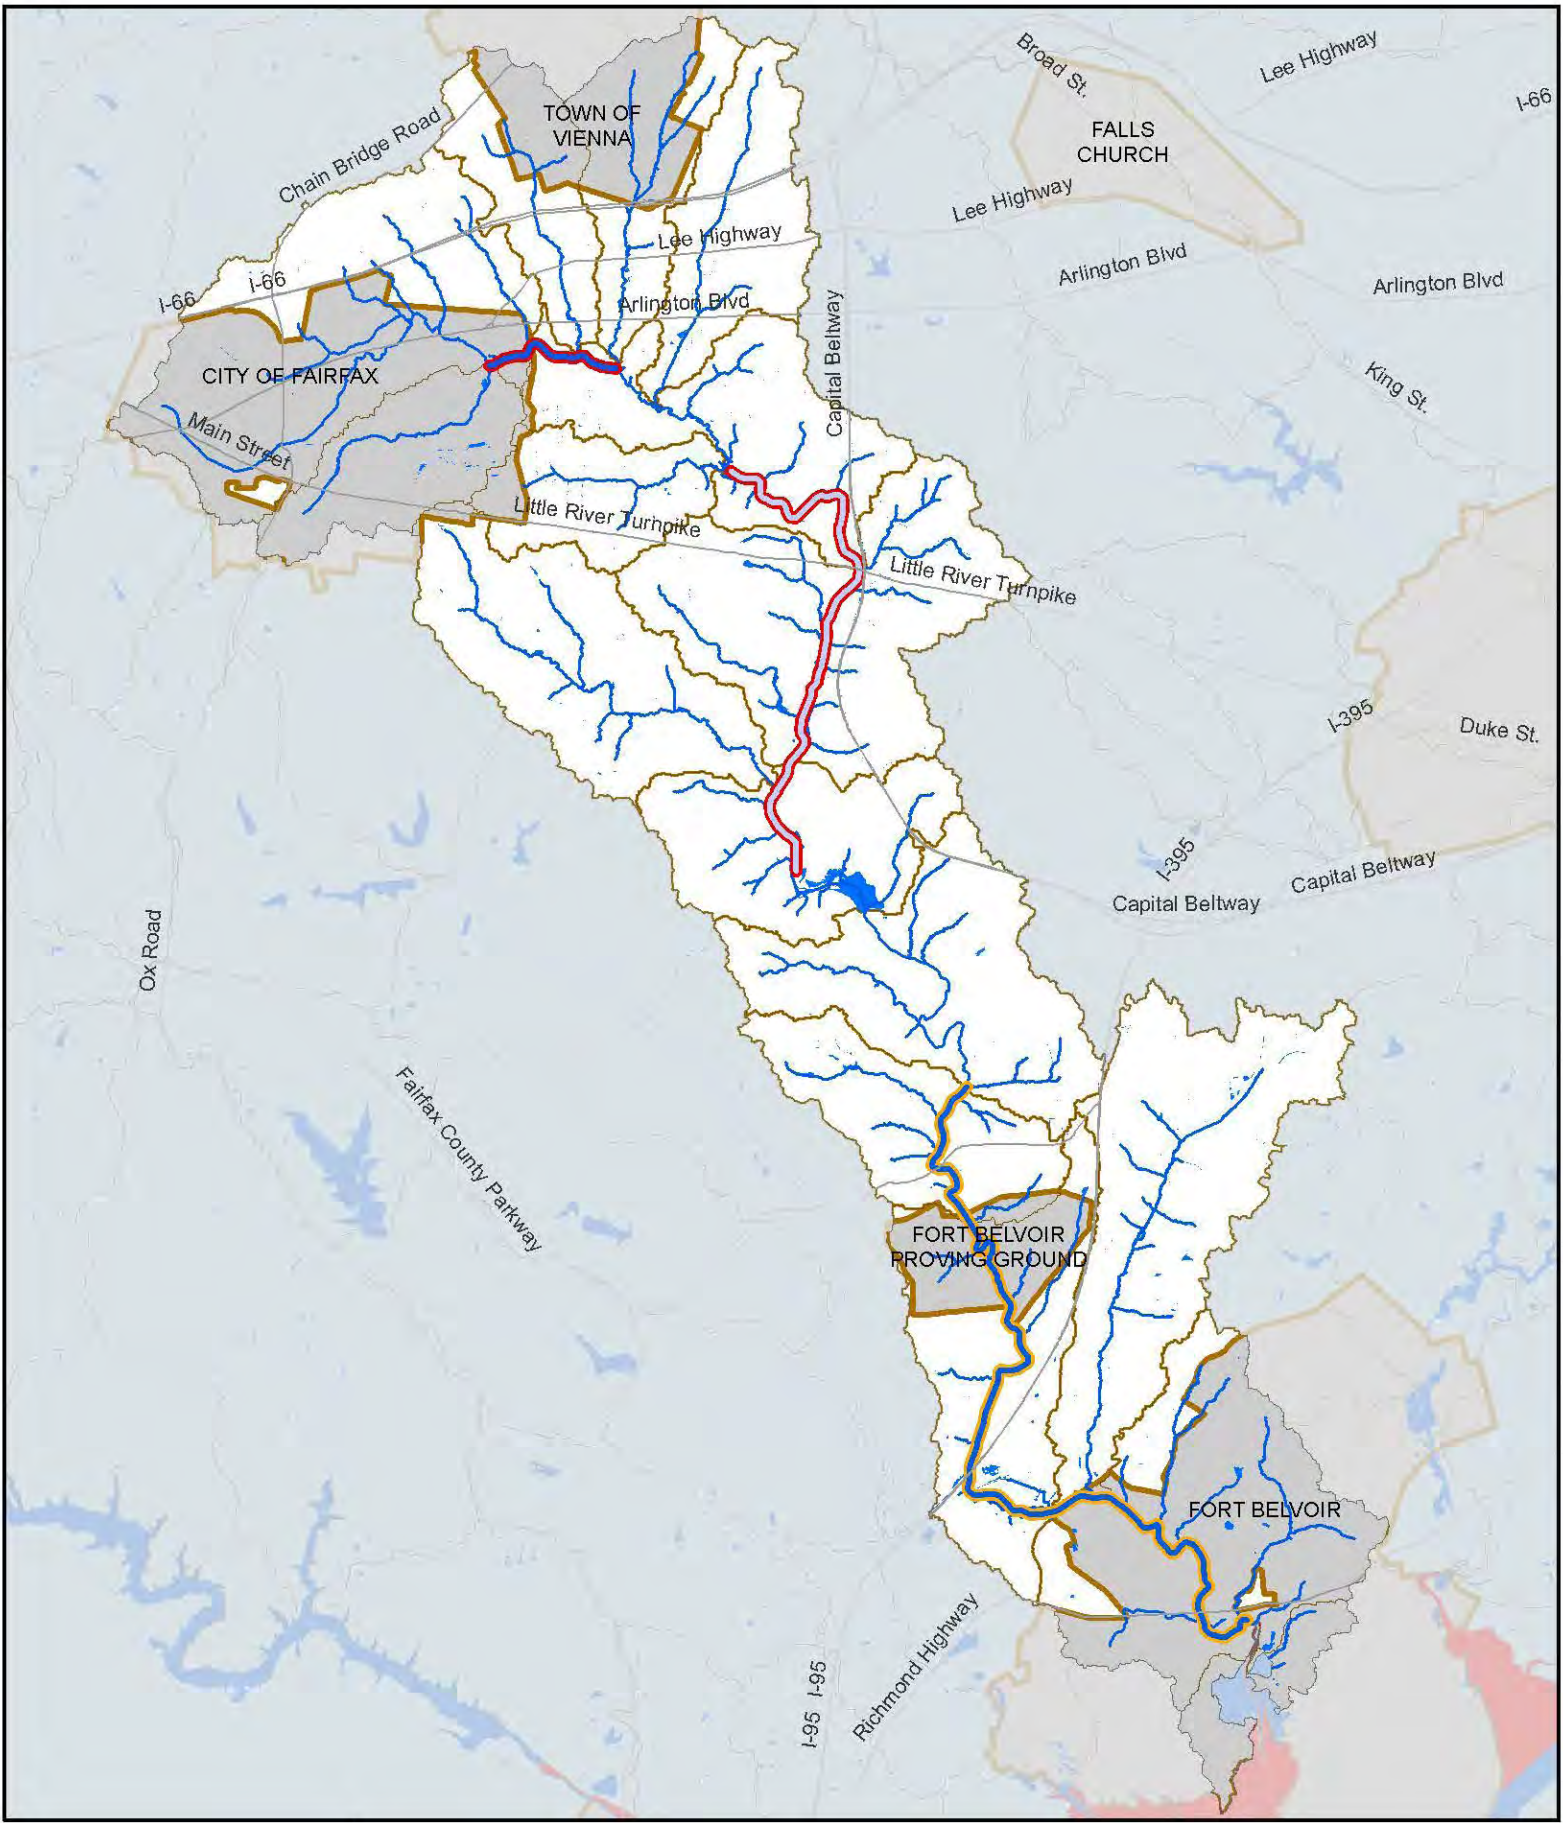
Map 1-6

- Impairments for benthic macroinvertebrates (listed 1996, TMDL schedule 2010) and E. coli (listed 2004, TMDL schedule 2016)
- Impairment for E. coli (listed 2004, TMDL schedule 2014)
- Impairment for E. coli (listed 1998, TMDL approved 2002)

Portions of the Accotink Creek watershed have been listed as impaired (Category 5) waters for benthic macroinvertebrate bioassessment (streams), fecal coliform and *E. coli* (see Map 1-6). Accotink Creek, from the confluence with Calamo Branch to the tidal waters of Accotink Bay, was first listed for benthic macroinvertebrate bioassessments in 1998 and has a Total Maximum Daily Load (TMDL) schedule of 2010. This same segment was listed in 2004 for a fecal coliform impairment, with a TMDL schedule of 2016. Also in 2004, the segment of Accotink Creek from its confluence with Daniels Run in the City of Fairfax to its confluence with Bear Branch was listed as impaired for *E. coli* with a TMDL schedule of 2014.

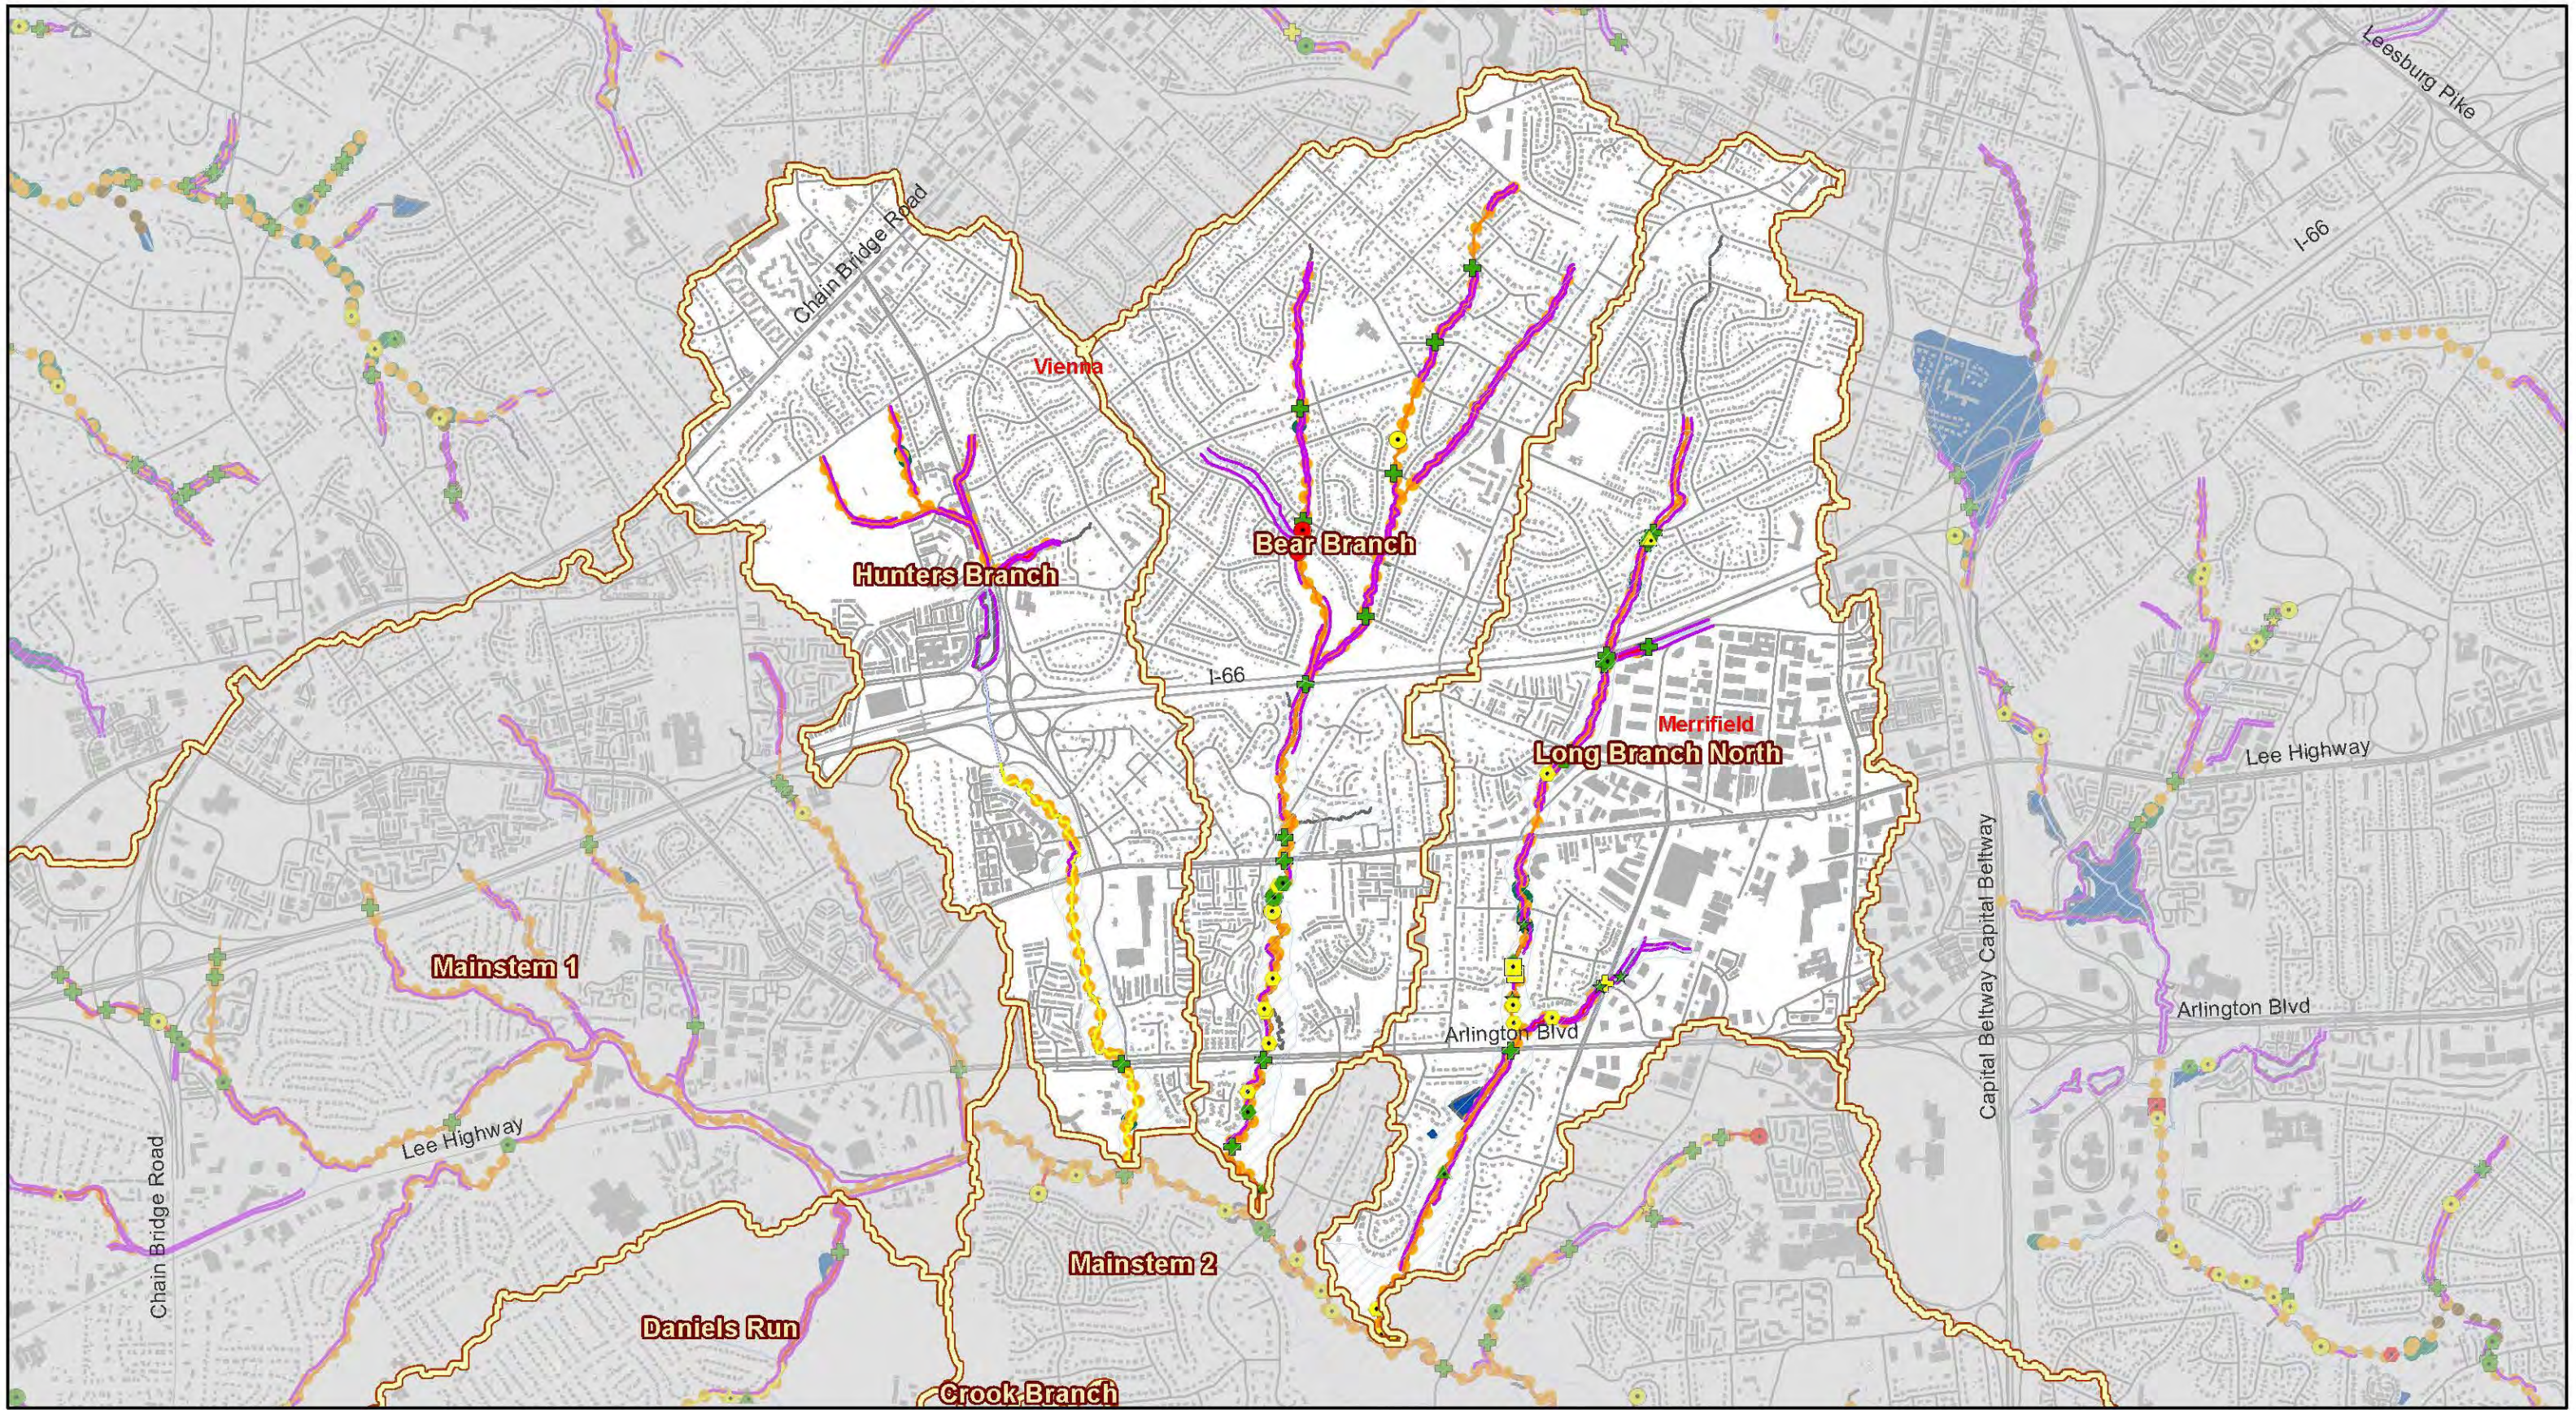
Map 2-6
Stormwater Infrastructure Map
 Hunters Branch
 Bear Branch
 Long Branch North

Obstruction Impact	Dump Site Impact	Pipe Impact	Ditch Impact	Utility Impact	Crossing Impact	Head Cut Height
● Minor to Moderate	★ Minor to Moderate	● Minor to Moderate	■ Minor to Moderate	● Minor to Moderate	✚ Minor to Moderate	▲ 0.5' - 1.0'
● Moderate to Severe	★ Moderate to Severe	● Moderate to Severe	■ Moderate to Severe	● Moderate to Severe	✚ Moderate to Severe	▲ 1' - 2'
● Severe to Extreme	★ Severe to Extreme	● Severe to Extreme	■ Severe to Extreme	● Severe to Extreme	✚ Severe to Extreme	▲ >2'
Habitat Rating	CEM Category		Resource Protection Area (RPA)		Lakes and Ponds	Deficient Buffer
— Excellent	● CEM 2 - Incising	▨ RPA	■ Lakes and Ponds	— Deficient Buffer		
— Fair	● CEM 3 - Widening	▨ WMA Boundary	■ Erosion			
— Very Poor						
— Good						
— Poor						
— Unassessed

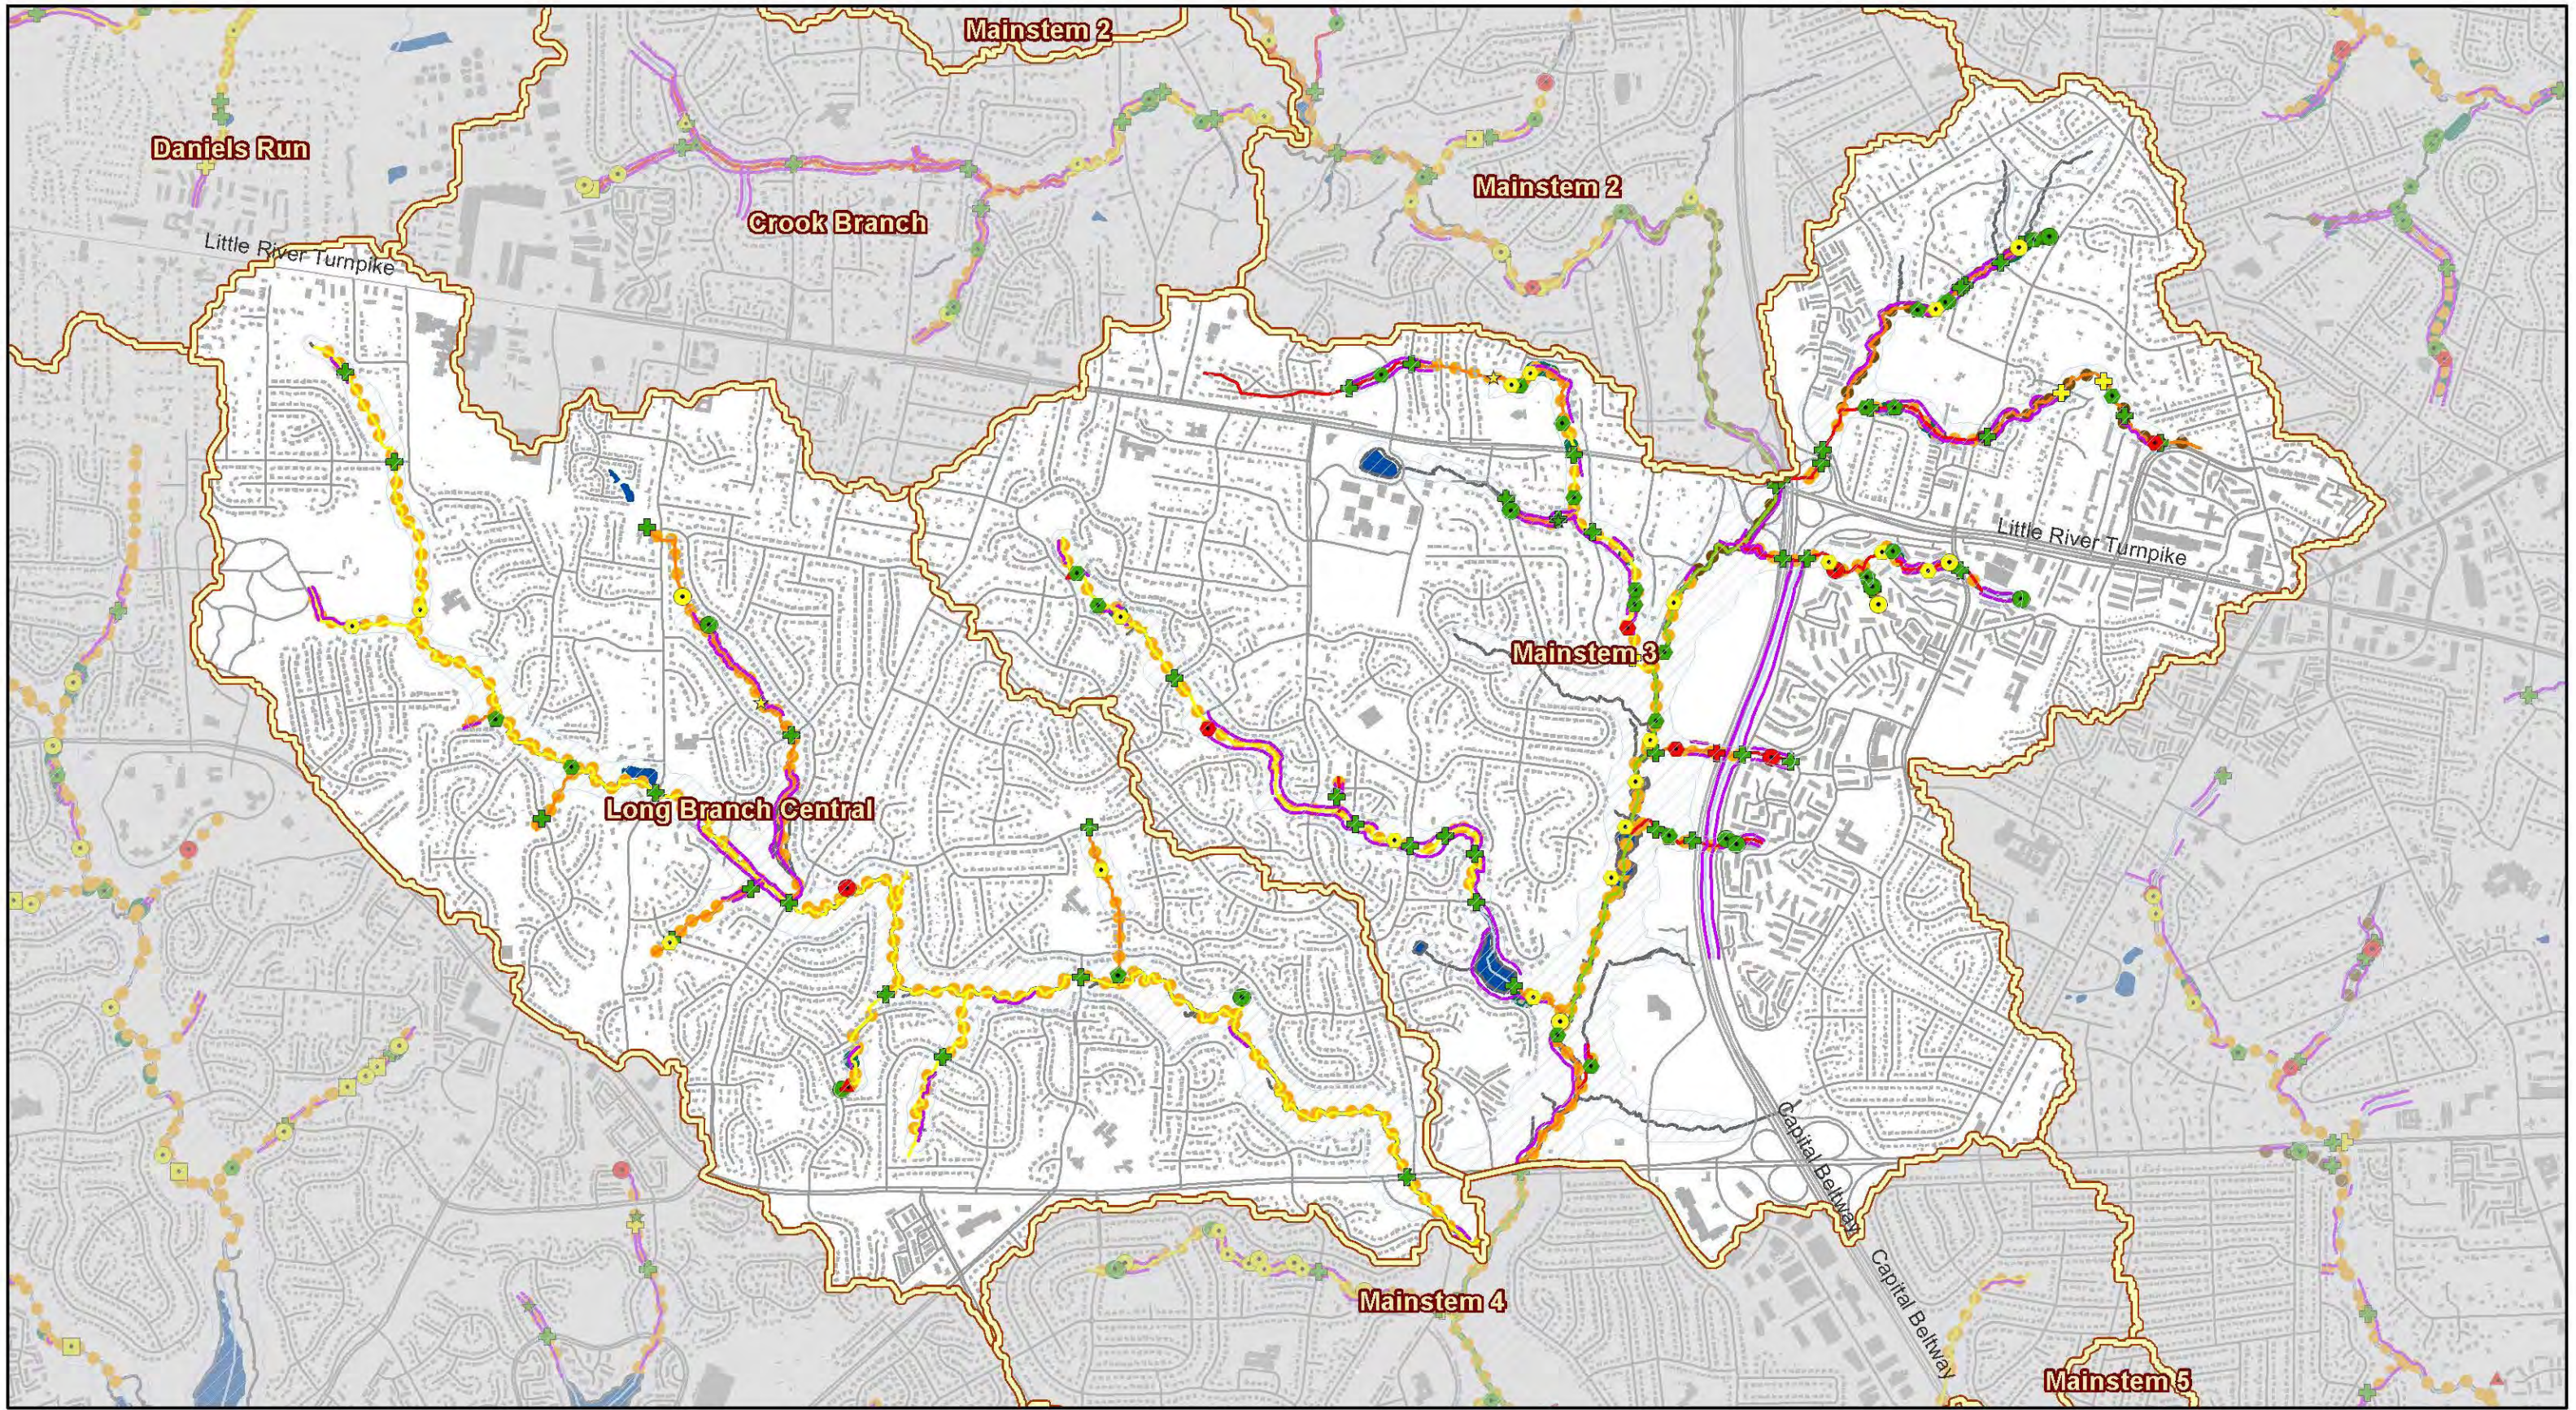
Stormwater Infrastructure Map

Long Branch Central
Mainstem 3

Obstruction Impact	Dump Site Impact	Pipe Impact	Ditch Impact	Utility Impact	Crossing Impact	Head Cut Height
◆ Minor to Moderate	★ Minor to Moderate	● Minor to Moderate	■ Minor to Moderate	⬠ Minor to Moderate	⊕ Minor to Moderate	▲ 0.5' - 1.0'
◇ Moderate to Severe	☆ Moderate to Severe	○ Moderate to Severe	□ Moderate to Severe	⬡ Moderate to Severe	⊕ Moderate to Severe	▲ 1' - 2'
◆ Severe to Extreme	★ Severe to Extreme	● Severe to Extreme	■ Severe to Extreme	⬠ Severe to Extreme	⊕ Severe to Extreme	▲ >2'
Habitat Rating			CEM Category			
— Excellent	— Fair	— Very Poor	● CEM 2 - Incising	□ Resource Protection Area (RPA)	■ Lakes and Ponds	— Deficient Buffer
— Good	— Poor	— Unassessed	○ CEM 3 - Widening	□ WMA Boundary	■ Erosion
