<ul style="list-style-type: none"> Subwatershed Boundary Roads Buildings Creeks/Streams 	<ul style="list-style-type: none"> Drainage Complaint Problem Locations Floodplains Paved Ditch 	Crossing Impact <ul style="list-style-type: none"> Minor to Moderate Impact Moderate to Severe Impact Severe to Extreme Impact 	Ditch Impact <ul style="list-style-type: none"> Minor to Moderate Impact Moderate to Severe Impact Severe to Extreme Impact 	Pipe Impact <ul style="list-style-type: none"> Minor to Moderate Impact Moderate to Severe Impact Severe to Extreme Impact 	<ul style="list-style-type: none"> Parcel Controlled by BMP Parcel Controlled by Detention Facility 	<ul style="list-style-type: none"> Dry Pond Wet Pond All Other Storm Facility Types 	Habitat Assessment <ul style="list-style-type: none"> No Assessment Very Poor Poor Fair Good Excellent 	<p>Map 7.1 Turkey Run Watershed Characteristics and Storm Drain Infrastructure</p>

Map 7.2
Turkey Run Watershed
Stream Geomorphology and
Habitat Quality

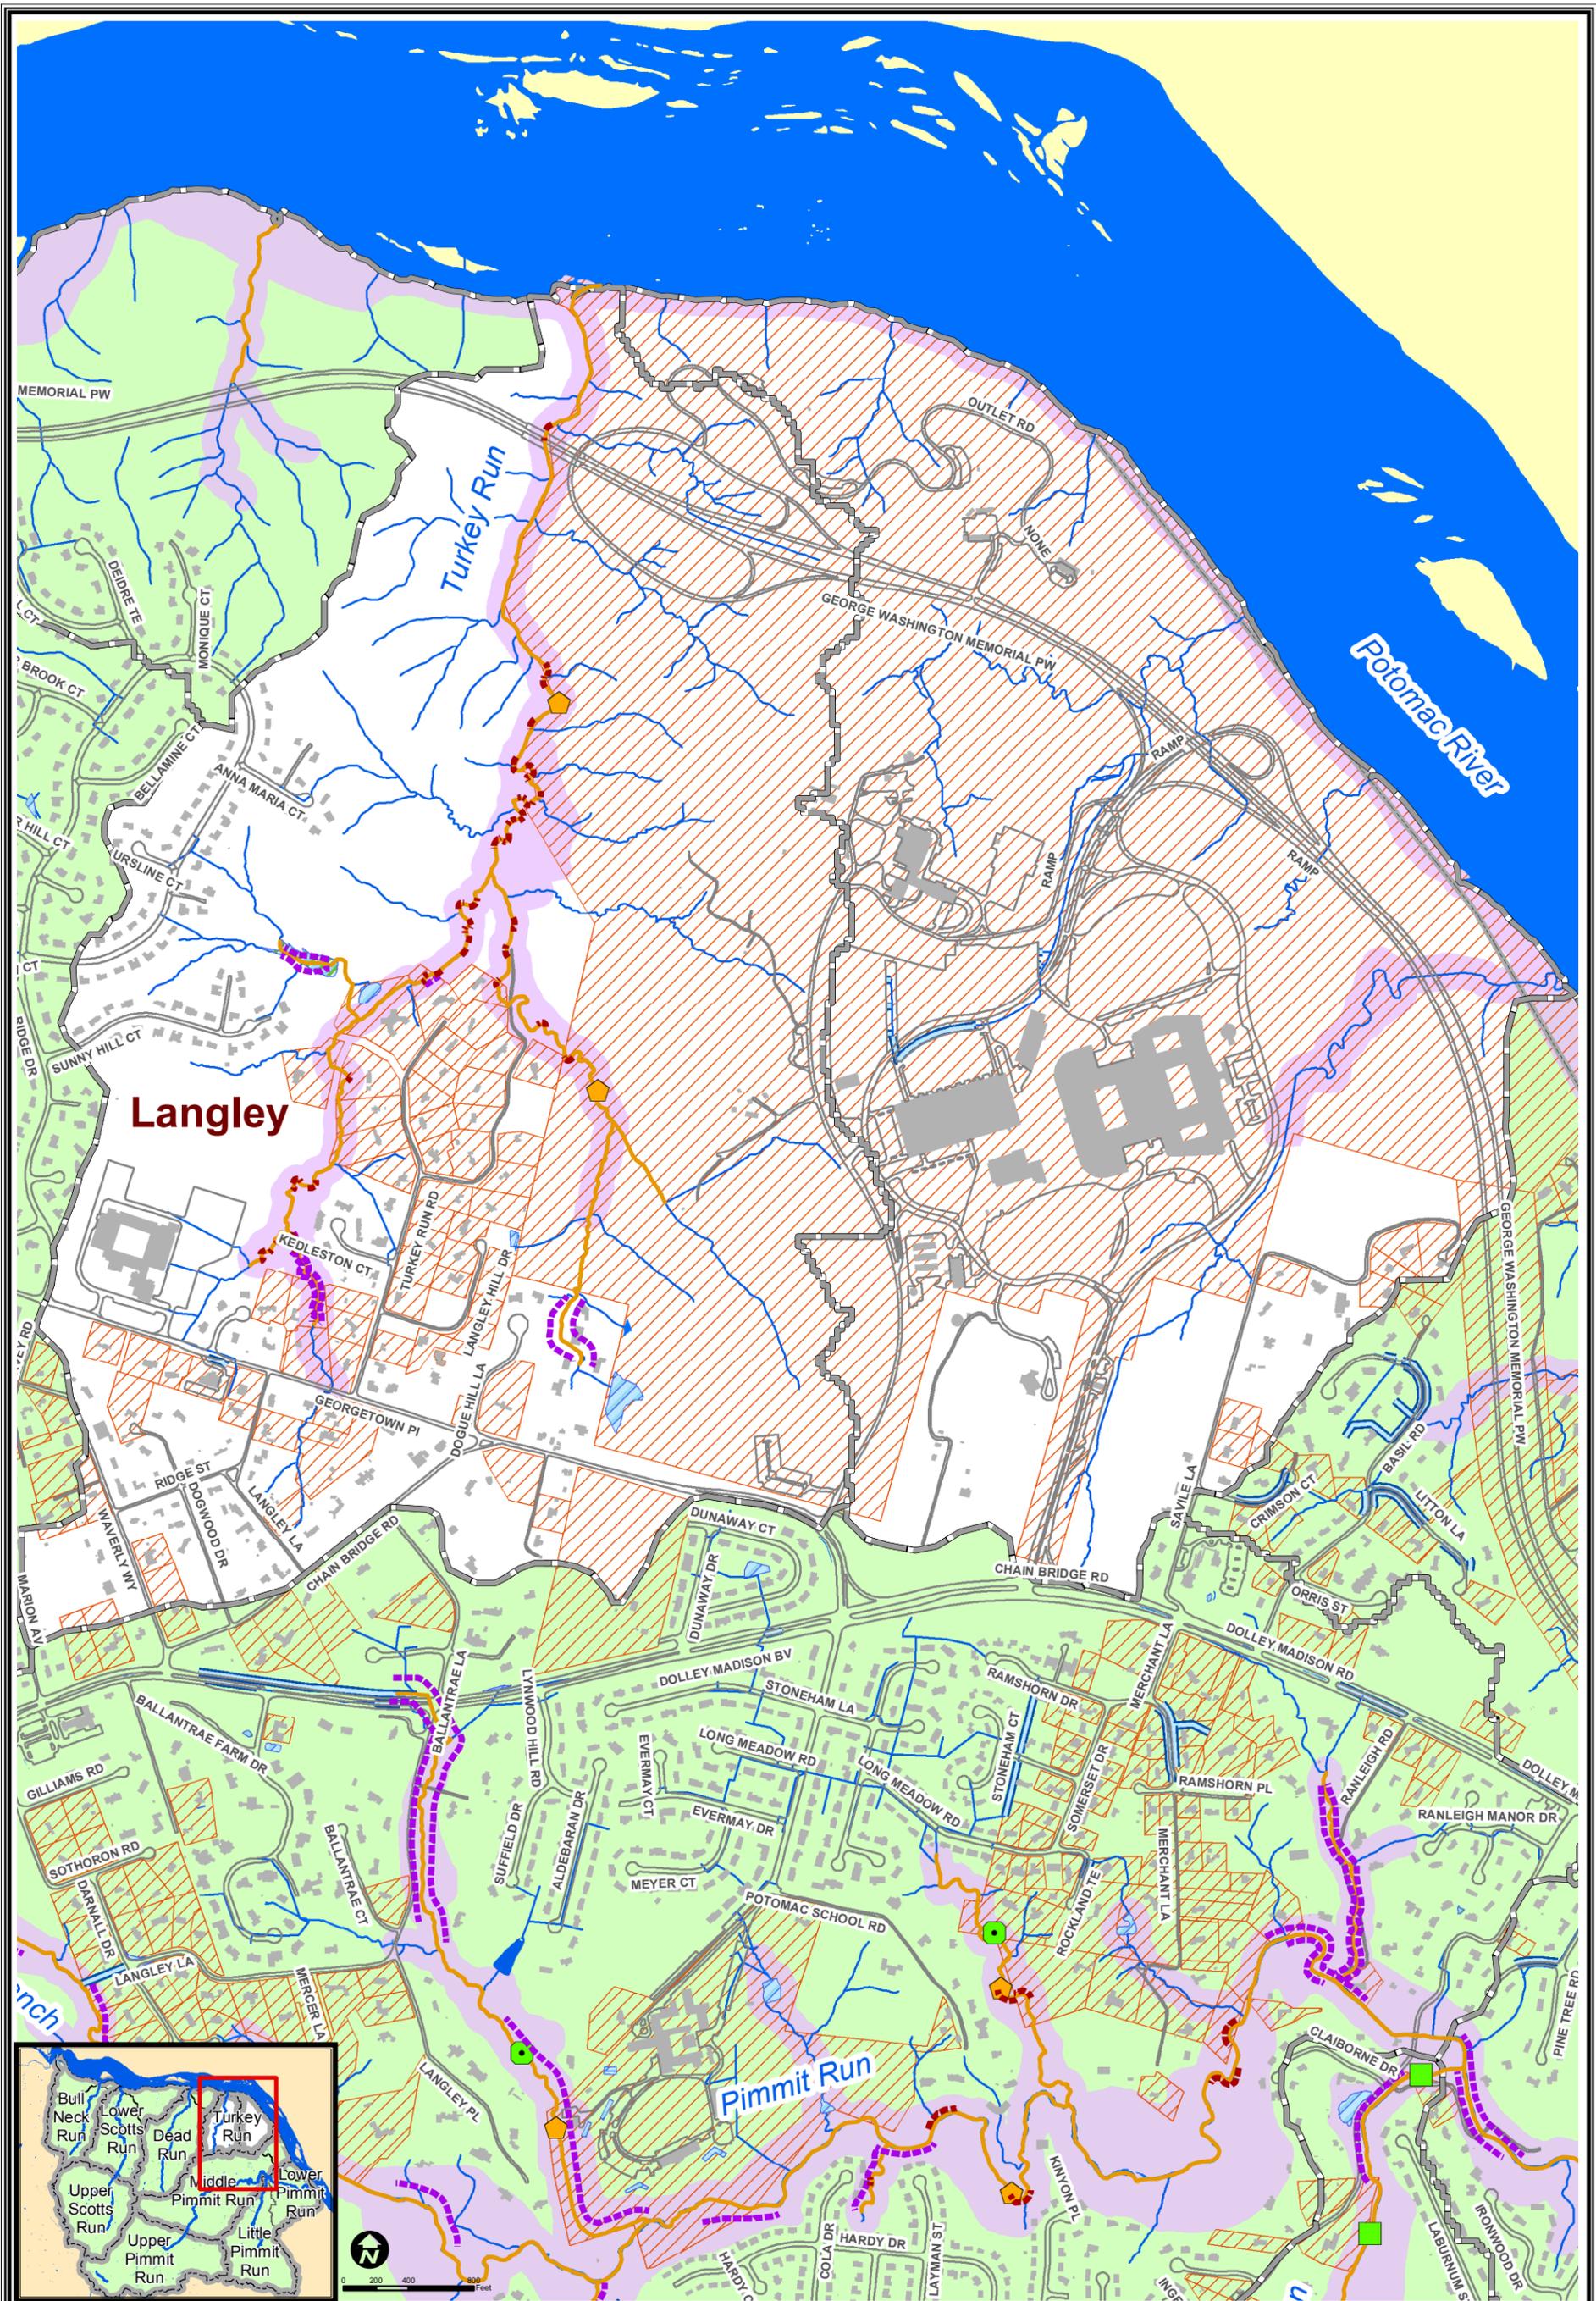
<ul style="list-style-type: none"> Subwatershed Boundary Roads Buildings 	<ul style="list-style-type: none"> Creeks/Streams Paved Ditch 	Obstruction Impact <ul style="list-style-type: none"> Minor to Moderate Moderate to Severe Severe to Extreme 	Utility Impact <ul style="list-style-type: none"> Minor to Moderate Moderate to Severe Severe to Extreme 	Dump Site Impact <ul style="list-style-type: none"> Minor to Moderate Moderate to Severe Severe to Extreme 	CEM Category <ul style="list-style-type: none"> No Assessment Stable Channel Incised Channel Widening Channel Stabilizing Channel Stable Channel 	Headcut Height <ul style="list-style-type: none"> 0.5' to 1' Height 1' to 2' Height > 2' Height 	Stream Impact <ul style="list-style-type: none"> Insufficient Buffer Erosion 	On-Site Sewage Disposal System
---	---	--	--	--	---	--	---	---------------------------------------
